## BPT 320 KB/R - Identification of correct electrical spare parts

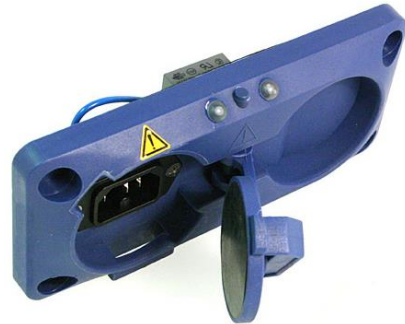
- 1 320 KB with bottom plate made from steel resp. round cover of power connector

Due to their age it is often impossible to seal them correctly. Therefore we do not offer spare parts any more. The focus is on preventing personal injuries.  
Whenever needed a defective unit can be returned to our factory to proof whether a repair is possible or not.

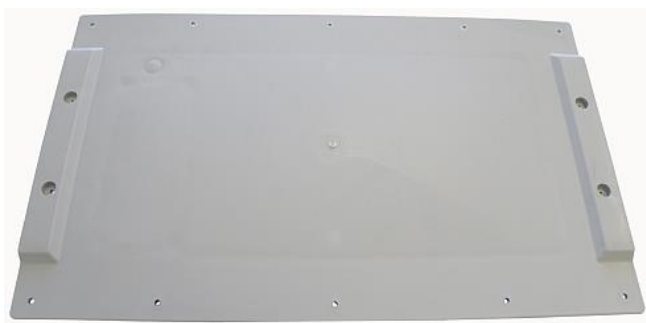
- 2    **320 KB/R with injection molded bottom plate with injection point in the middle (colours blue and grey)**

- 139788    repair kit BPT 320 KB panel and controller
- 118735    repair kit BPT KB panel
- 107023    repair kit BPT 320 KB/AS silicon heater up to 12/2011
- 118912    repair set BPT 320 KB/KBR bottom plate and gasket up tp 12/2011

- 128646    repair kit BPT 320 KBR panel and controller up to 12/2011
- 118736    repair kit BPT KBR panel
- 107024    repair kit BPT 320 KBR/AS silicon heater up to 12/2011 <sup>\*)</sup>
- 118912    repair set BPT 320 KB/KBR bottom plate and gasket up tp 12/2011

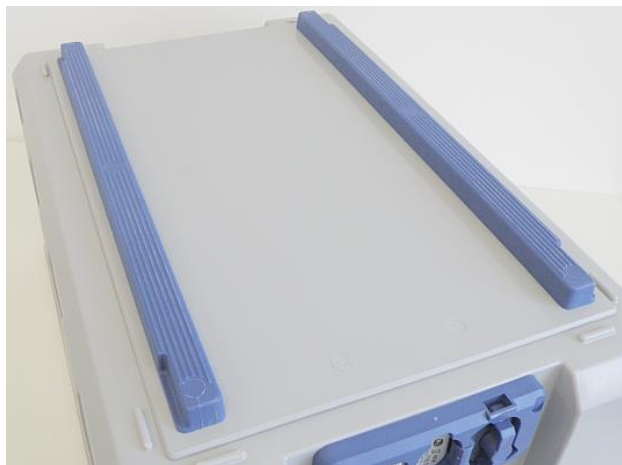
## 3 320 KB/R with machined plastic bottom plate (colour grey)

- 139788 repair kit BPT 320 KB panel and controller
- 118735 repair kit BPT KB panel
- 120010 repair kit BPT 320 KB/AS silicon heater from 01/2012
- 120009 repair set BPT 320 KB/KBR bottom plate and gasket from 01/2012 \*)

- 119916 repair kit BPT 320 KBR panel and controller from 01/2012 \*)
- 118736 repair kit BPT KBR panel
- 119917 repair kit BPT 320 KBR/AS silicon heater from 01/2012
- 120009 repair set BPT 320 KB/KBR bottom plate and gasket from 01/2012 \*)
